Operating Experience Weekly Summary 97-16

April 11 through April 17, 1997

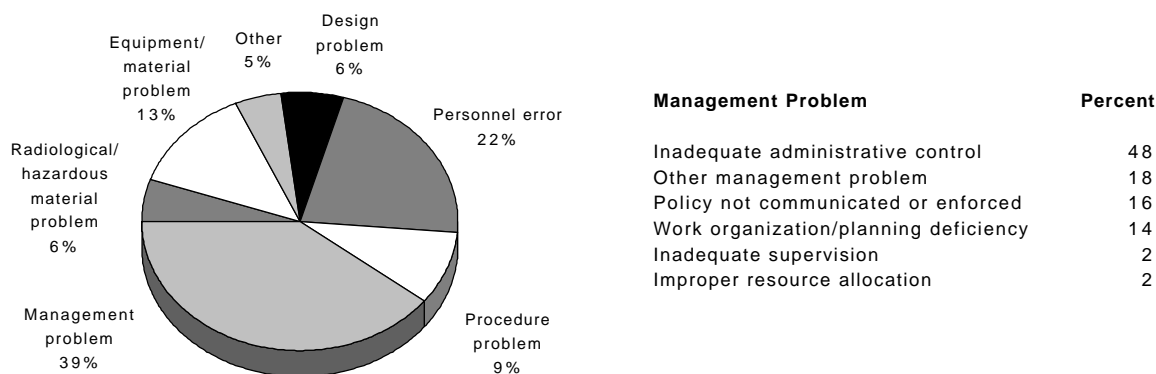
Figure 4-1. Root Causes of Personnel Contamination Events¹

Operating Experience Analysis and Feedback (OEAF) searched the Occurrence Reporting and Processing System (ORPS) database for reports of personal contamination events and found 2,853 occurrences DOE-wide. Figure 4-1 shows the breakdown of these events by root cause. Facility managers most often reported management problems as the root cause, and this category accounts for 43 percent of the events. Further review shows that 14 percent of management problems were reported as work organization planning deficiency.

¹ OEAF engineers reviewed the ORPS database for Nature of Occurrence "4B" (Personnel Contamination) and found 2,627 reports containing 2,853 occurrences.
